Product Information Note # 025

Subject: **Fibre Channel Option
Firmware Update**

Revision Date: **19 NOV 01**

Revision: **C**

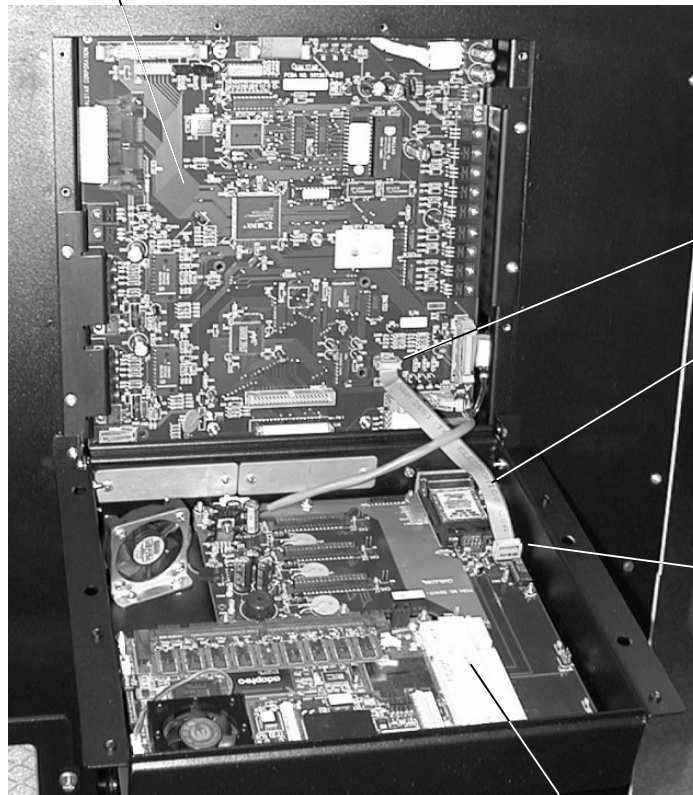
Figure 1 Executive PCBA and Fibre Channel Option

1. The FCO with loader version 5016 and earlier, will not upload correctly with the TLS serial interface connected.
 - a) First power off the TLS, then disconnect the serial interface ribbon cable between the TLS executive PCBA and the FCO, then power on the TLS library. See Figure 1.

- b) Upload the program. See page 1 for instructions.
- c) Power off the TLS, then reconnect the serial interface cable between the TLS executive PCBA and the FCO.
- d) Power on the TLS.
